# SIERRA LEONE

RAPID DAMAGE AND LOSS  
ASSESSMENT OF AUGUST 14TH, 2017  
LANDSLIDES AND FLOODS IN THE  
WESTERN AREA

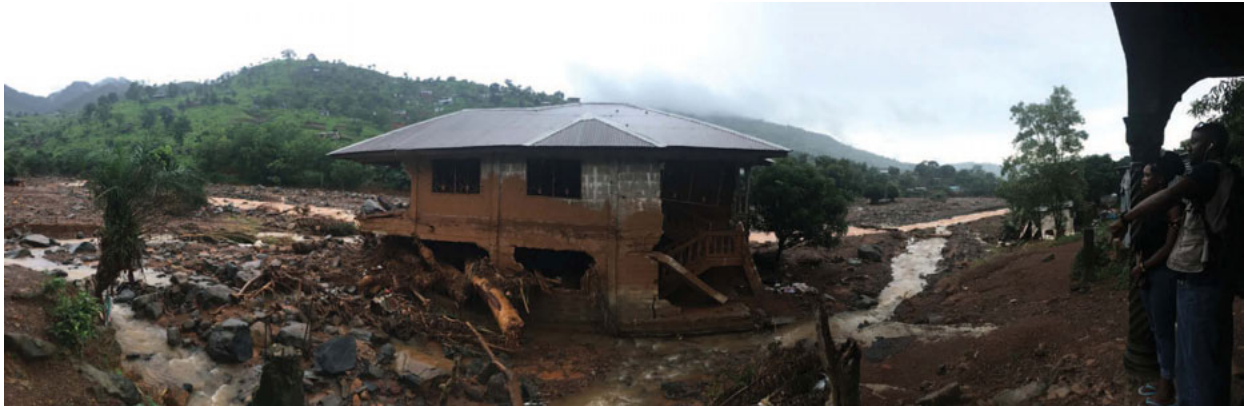
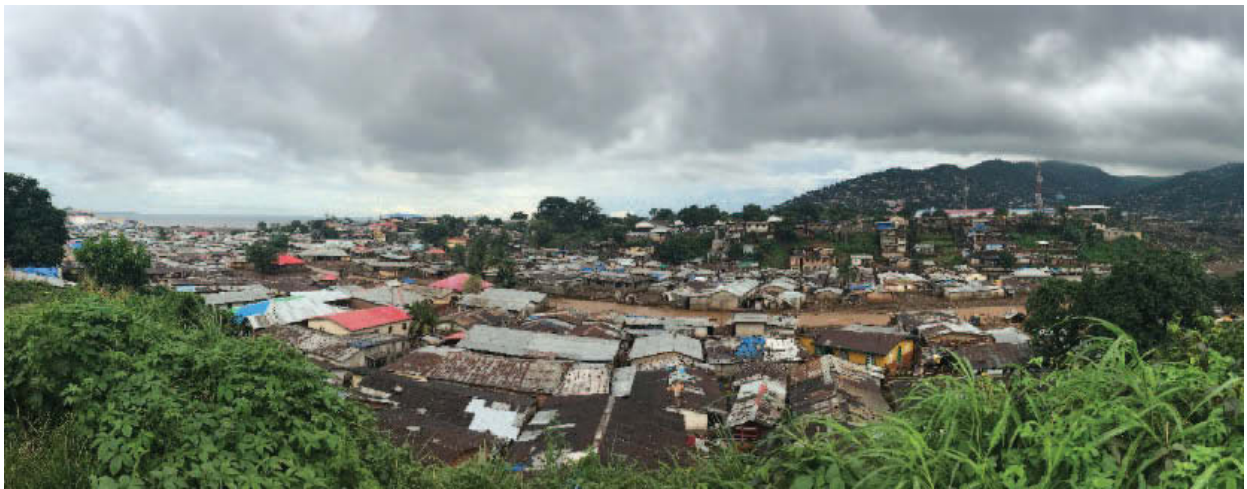
**FIGURE 10:** Construction Typology by Wards in Landslide Affected Region

**Although there were a few of the larger concrete reinforced buildings in Kamayama/Malama and Juba/Kaningo, most were either of informal or of masonry construction.** Residential buildings in the Western Area Rural are made of more durable construction materials, and are predominantly not shared units—most of these have been built in the last 15 years. The legal status by way of land or construction permits (split between two ministries) remains unclear. Detached single family homes in this area make up 37 percent of the residential building stock, of which almost half are owner-occupied homes inside private compounds. Building walls are predominantly constructed with cement blocks or mud bricks, while the roofing is made of zinc sheets. By contrast, in the Western Area Urban (where Freetown is located), buildings are made of less durable construction materials and are predominantly shared. Severe overcrowding is the norm, with an average of more than 10 people living in a single dwelling. Almost 60 percent of the households are renters. About 40 percent of the housing stock is made with cement block walls and zinc sheet roofs, and 35 percent have walls made from mud bricks.

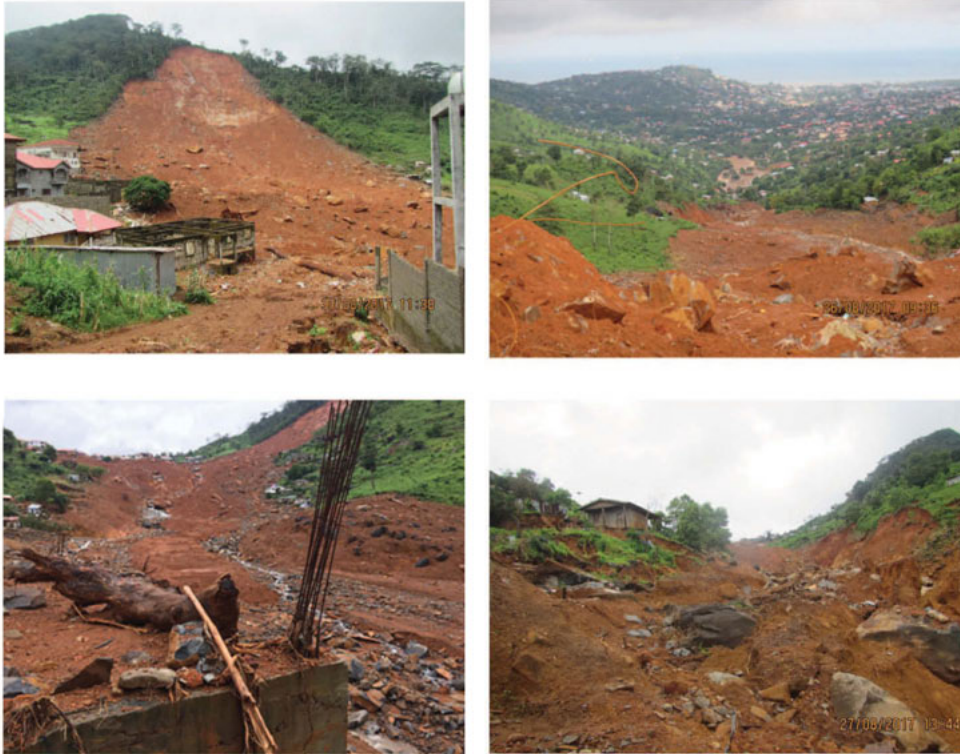
**PHOTO 1:** Photographs of Regent Landslide Area and Immediately Downstream along River Course

**Satellite imagery pre- and post-event very clearly shows the damage caused by the debris flow to the valley floor as it advanced downstream from Regent.** The river channel has changed considerably and is now much wider (100 m as shown in Figure 12) with the river course dividing in a number of locations, from its previous single course. Although Kamayama/Malama is at least 3 km from the landslide zone, it was still severely affected by the run-out and the force of

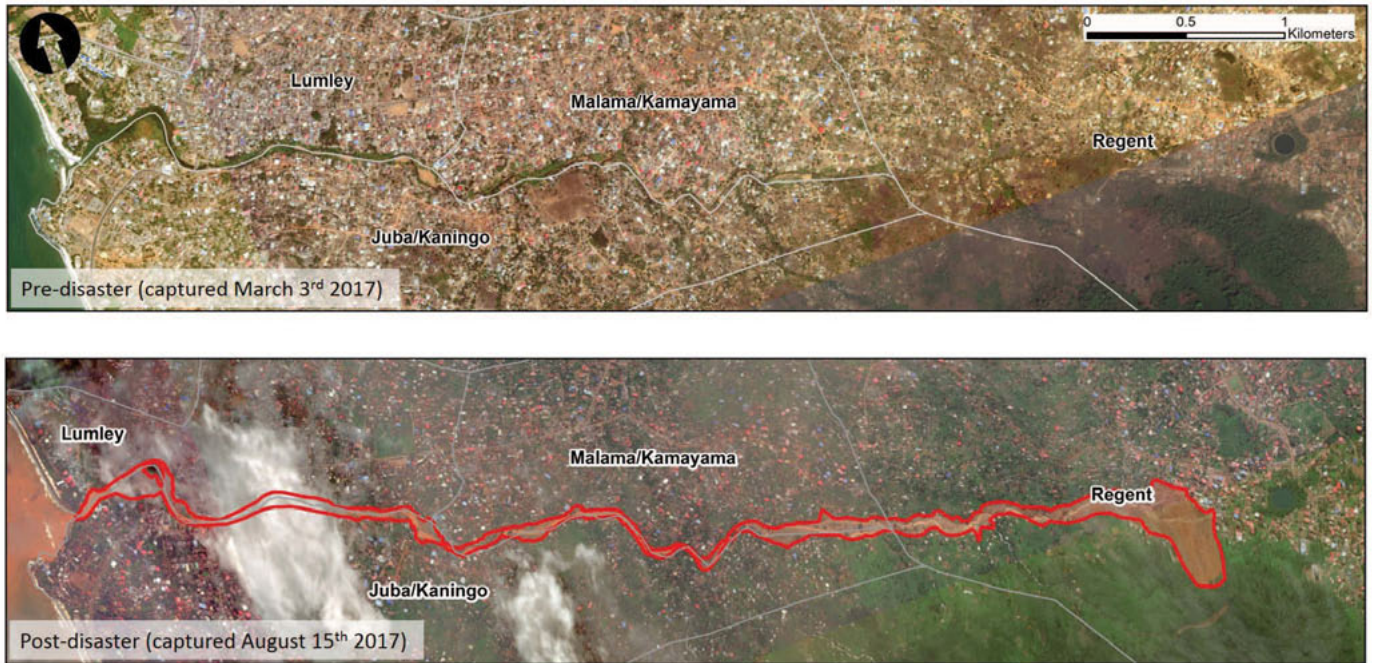
**FIGURE 11:** Pre- and Post-Disaster Satellite Imagery Showing the Affected Area from Regent to Lumley

deposition becomes more significant. It is likely though that tree trunks and lighter objects, including building materials, were carried further than the boulders (Figure 11).

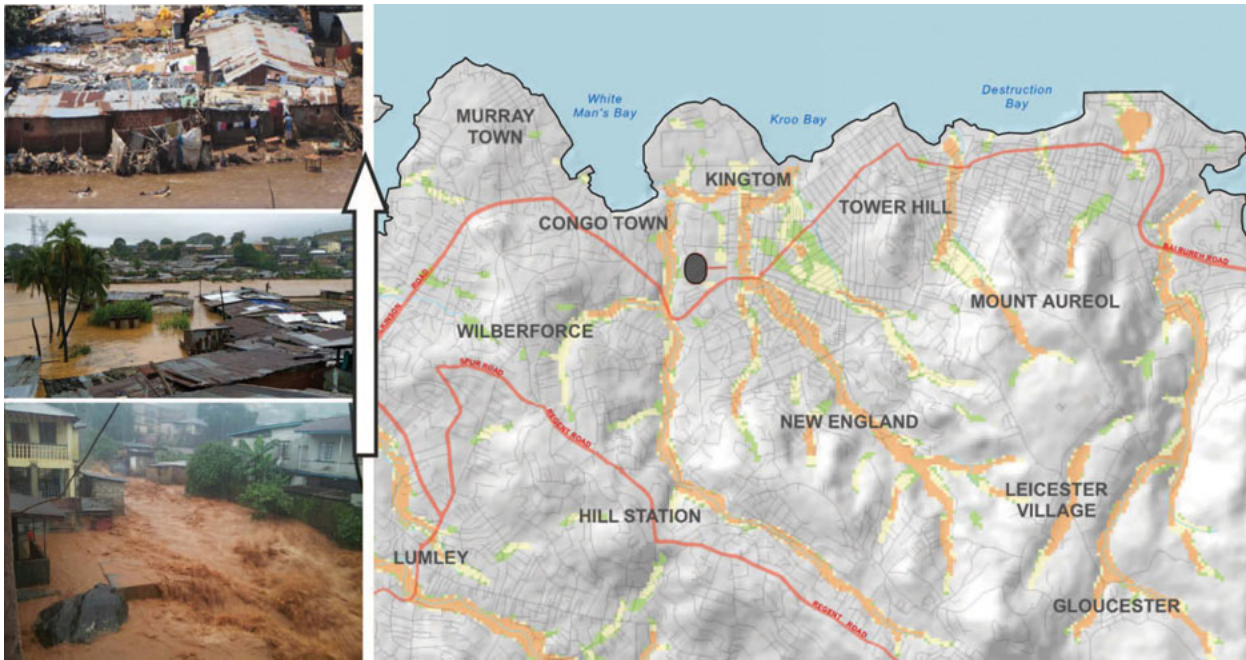
**FIGURE 13:** Flood Hazard in Western Area Urban, Northern Freetown—Examples of Recent Widespread Flooding from Culvert and Congo Town Regions

Note: The flood hazard changes as you move from the high mountains in the south to the lower lying flat land in the north (as indicated by the arrow).  
Source: World Bank, Arup (2017).

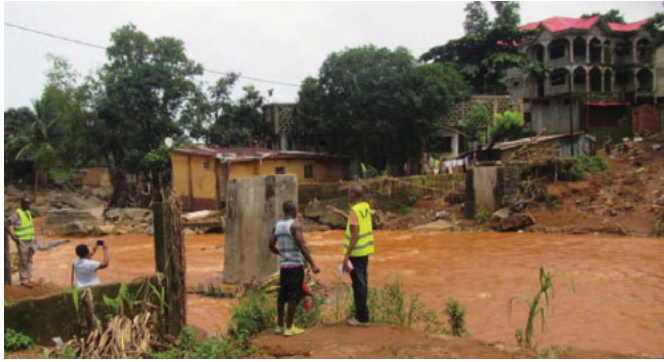
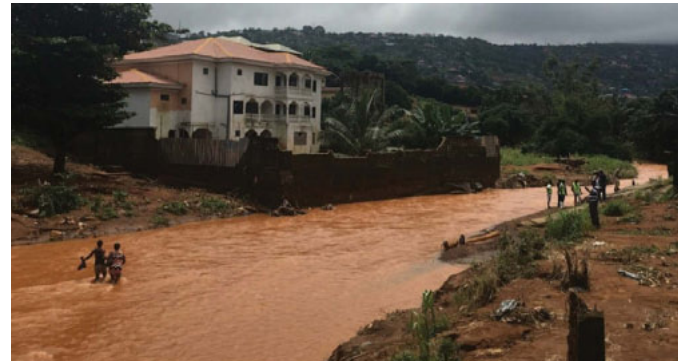
**FIGURE 17:** Affected Roads, Bridges and Pathways by the Regent-Lumley Landslide

Collapsed bridge at Kaningo (Sheriff Drive)

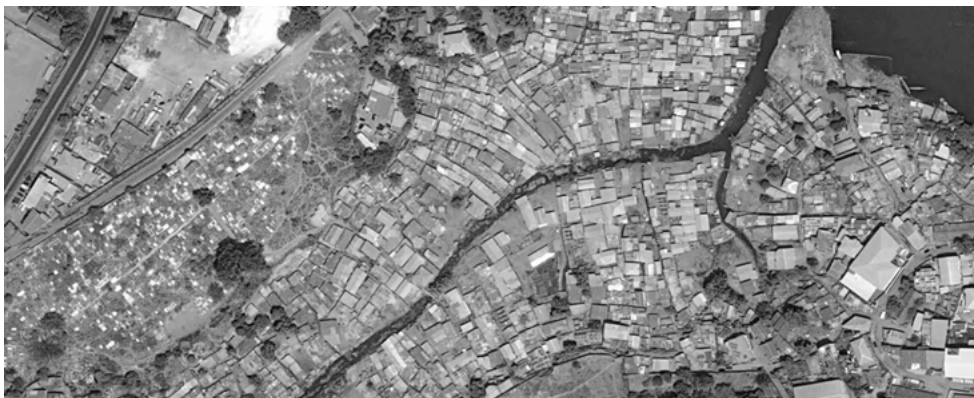
**FIGURE 36:** Example of High Density Area Near Estuary at Granville Brook/Bomeh Dump Site Prior to Flooding

**There are two dump sites, both posing very high risks to the dense residential communities where they are located—The partially fenced Granville Brook or “Bomeh” where the garbage piles are 10–15 meters high, and the King Tom site.** Less than half of the 500–600 tons of solid waste (household, medical, hazardous, and toxic waste) generated in Freetown reaches these sites (Figure 36 and Figure 37).

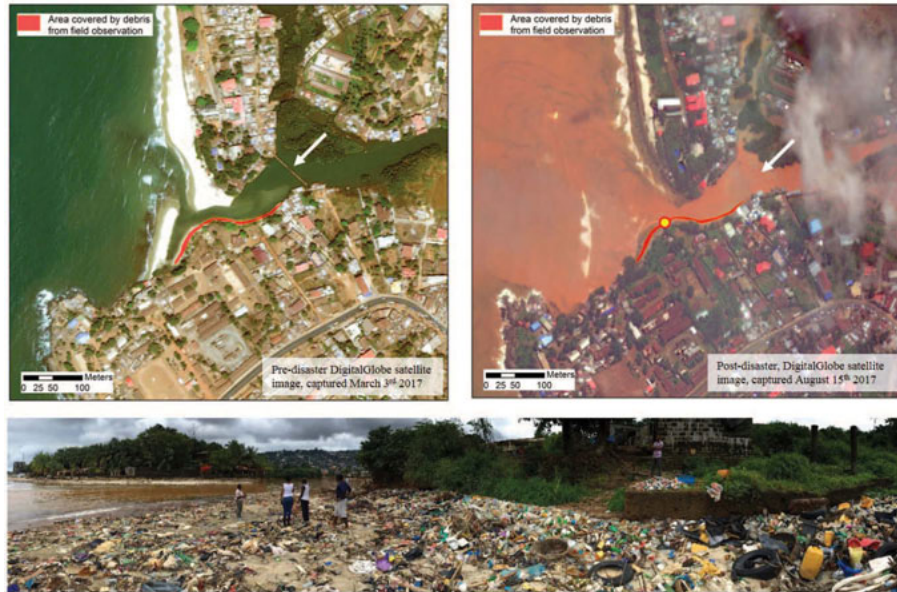
**FIGURE 38:** Debris at Lumley Creek Resulting from Flooding and Debris Flow Related to Regent Landslide Disaster

Note: The yellow circle indicates the location of the panorama above, which shows a view from east to west across the beach. The white arrows indicate the Lumley footbridge, which is submerged in the post-disaster imagery. The aerial extent of the debris was mapped in GIS based on field observations in the Lumley Creek area.
